## DAILY REPORT

RIVERTON APARTMENTS - TOWER B

2026-08-26

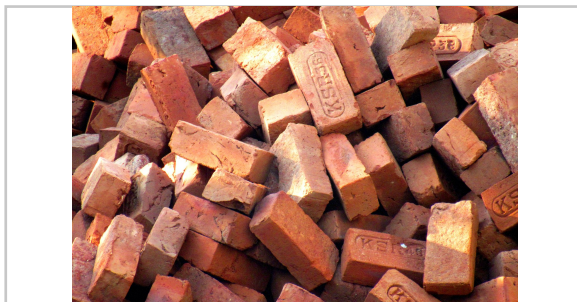
3

The ground-floor loading-dock wall return reached door-head height. Four chipped face bricks were segregated and serviceable stock was used. The final course remains open pending the lintel check.

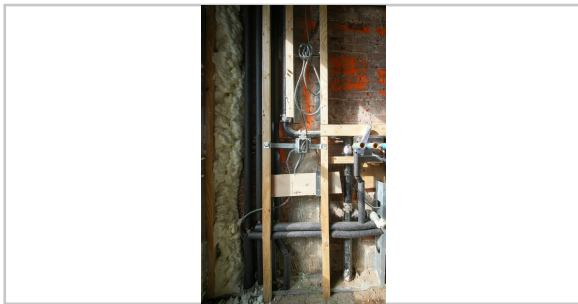
The vanity waste in the Unit 607 ensuite conflicts with the joinery nib by approximately 60 mm. The location was tagged and the wall remains open pending confirmed set-out.

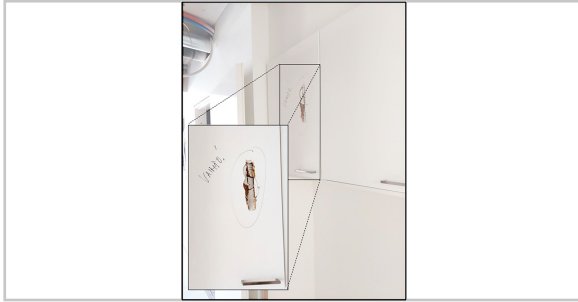
Kitchen joinery packs for Units 503-506 were received. Tall-unit panels for Unit 505 were missing and one Unit 506 end panel was damaged. Serviceable packs were moved to Level 5 and stored dry; the supplier was notified.

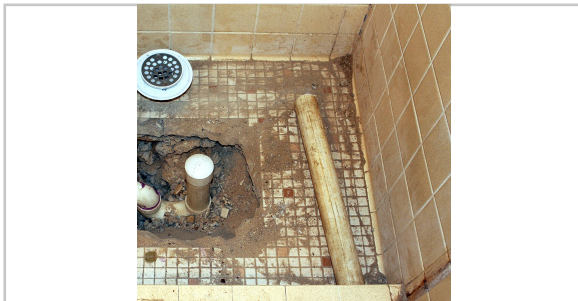
The Unit 604 bathroom flood test passed. Membrane lifting of approximately 80 mm was identified at the west side of the Unit 605 floor-waste flange. Tiling in Unit 605 is on hold pending rectification and reinspection.

The defective membrane at the Unit 605 floor waste was removed, reprimed and patched with the required lap. The repair is curing and remains subject to reinspection before tiling.

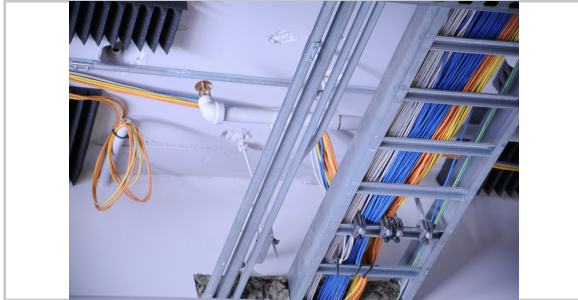
Approximately 12 m of Level 6 corridor ceiling outside Units 606-608 was placed on hold due to a clash between the sprinkler main and cable tray within the bulkhead zone. The ceiling crew moved to the lift lobby pending direction.

The architect's RFI response approved a 100 mm reduction to the Level 6 corridor bulkhead. Fire and electrical services are to be reset within the revised zone before ceiling work resumes from the lift-lobby end.
